RESIDENTIAL INSPECTION

94A Chelsea St
Christchurch, Canterbury 8062

JANUARY 27, 2025

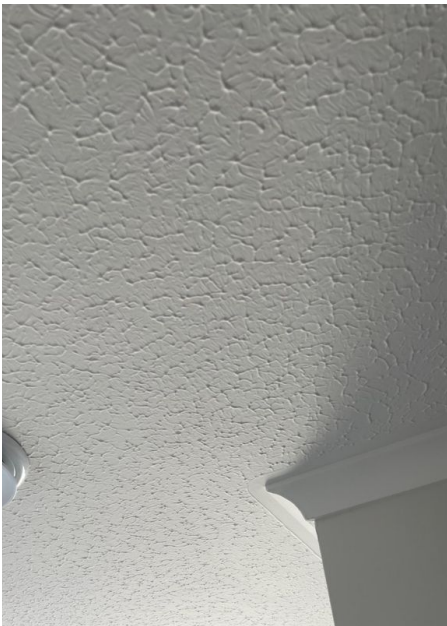
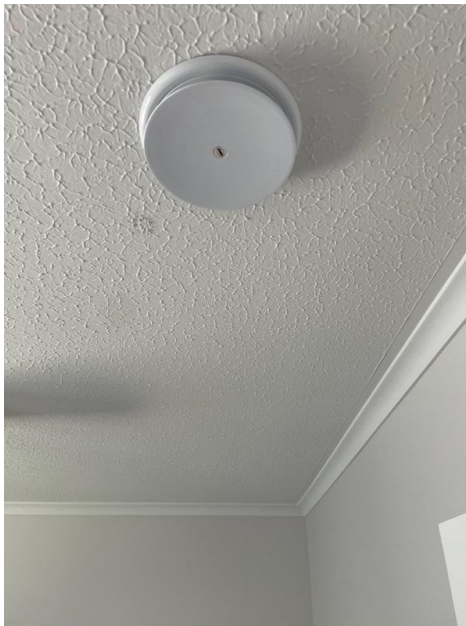
Potential asbestos: Ceiling stipple

The texture on the ceilings throughout the dwelling may be the type that contains Asbestos, although this can only be determined by testing a sample.

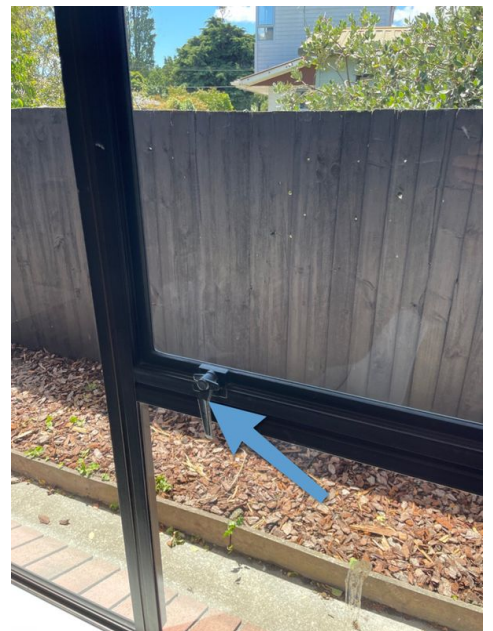
3.4.1 Windows & Reveals

LATCHES BROKEN OR WORN

The latches are loose to the highlighted area and require repair or replacement

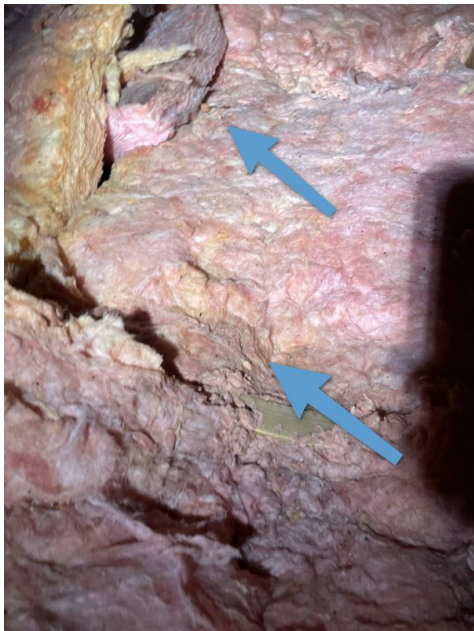
13.5.1 Pest & Insect

RODENT SIGN

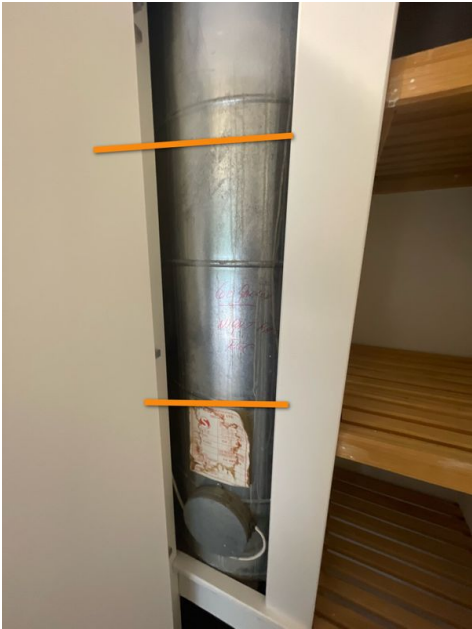
The HWC is beyond its life expectancy and should be considered for replacement

We recommend fitting seismic restraints to prevent movement during an earthquake.

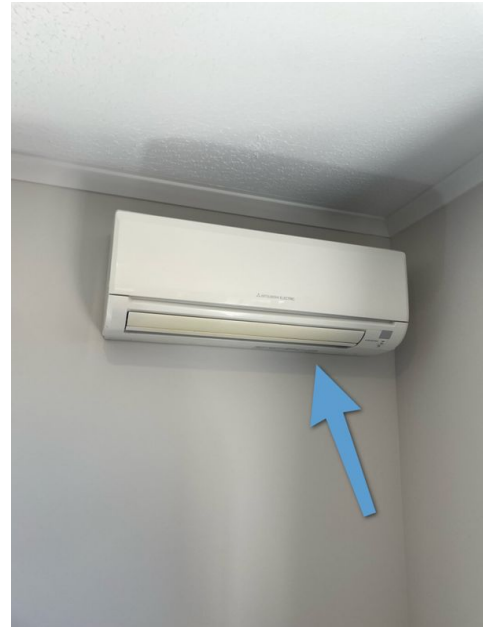
15.1.1 Heating & Air Conditioning

NO POWER TO HEATPUMP

The heatpump was not powering up at the time of inspection. All switches appeared to be on. It is recommended that the unit be tested at settlement inspection and repaired if required

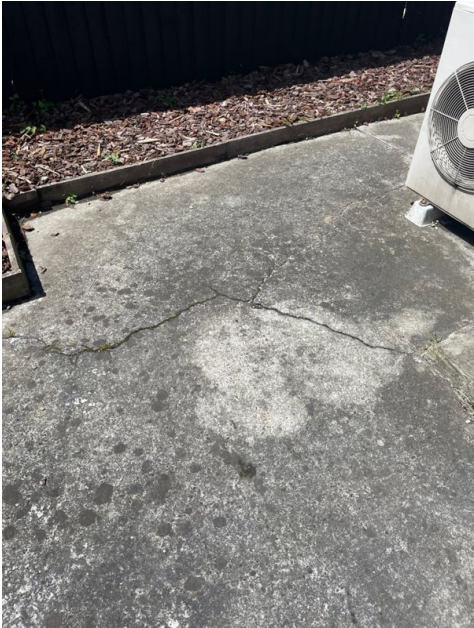
16.3.1 Path & Patios

CRACKING TO CONCRETE PATHS

There are hairline cracks to the concrete paths, this is common and is generally caused by shrinkage / movement of the material. These areas can be repaired or replaced by a concrete placer if desired

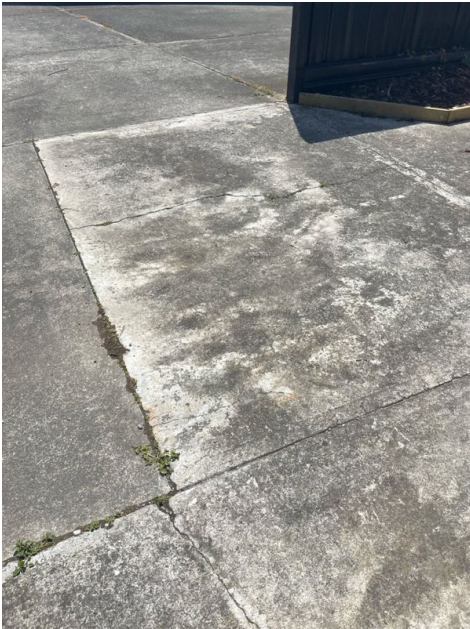
16.4.1 Driveway

CRACKING TO CONCRETE DRIVEWAY

There are hairline cracks to the concrete paths, this is common and is generally caused by shrinkage / movement of the material. These areas can be repaired or replaced by a concrete placer if desired

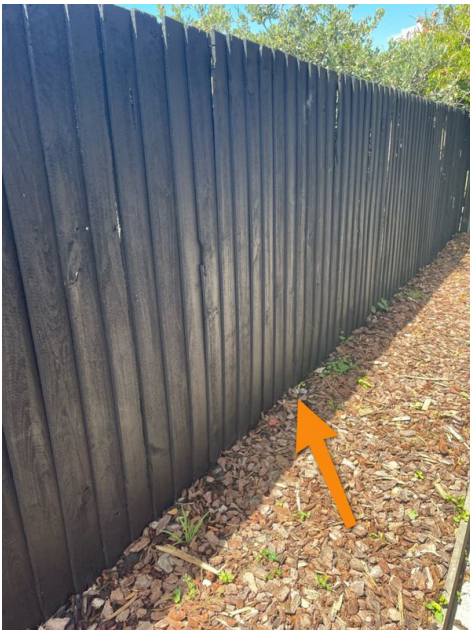
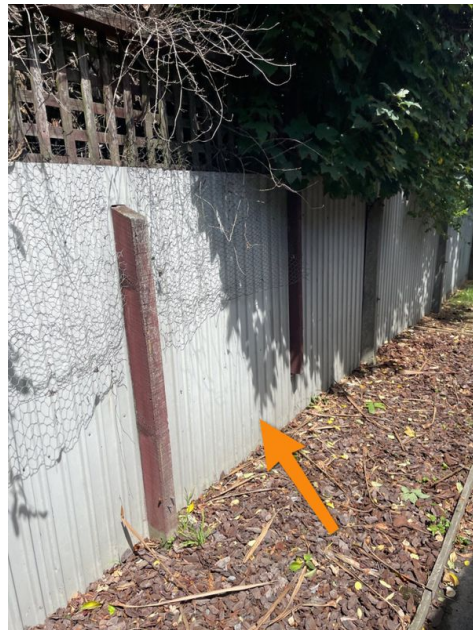
16.5.1 Fencing

FENCING HARD TO GROUND

The timber fencing is hard to the ground in areas. This will cause the fence palings to rot in time. It is recommended that clearances are instated to these areas

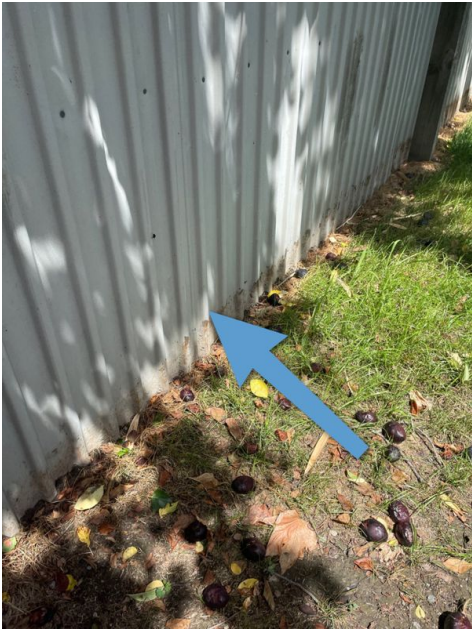
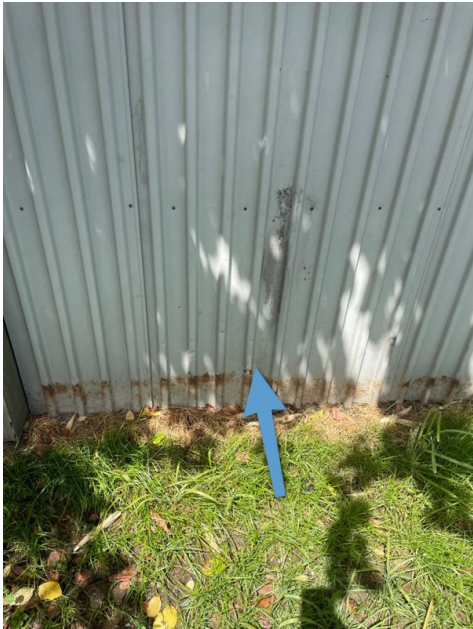
16.5.2 Fencing

CORROSION TO METAL FENCE

There is corrosion to the metal fence. Treatment and recoating of these areas is advised

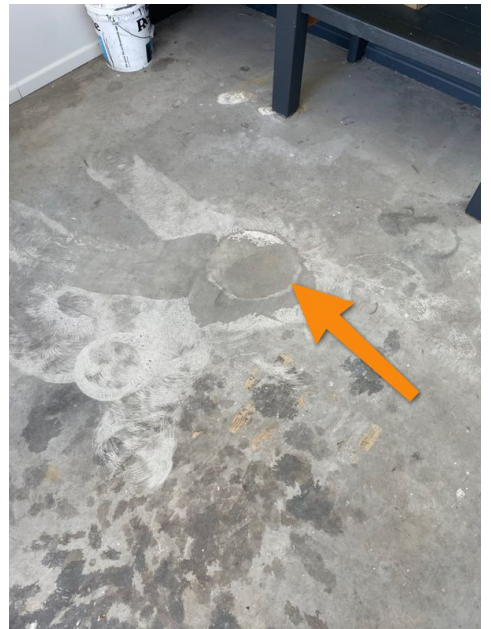
FOUDNATION RELEVELING OBSERVED

Concrete releveling is observed to the floor slab. The repair appears to have been made to a trades like manner

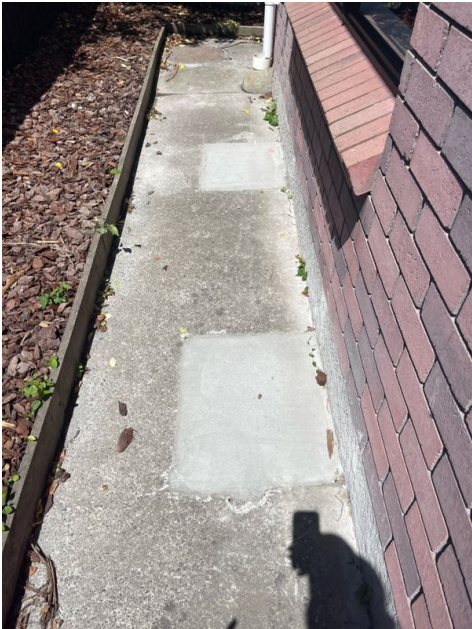
18.2.1 Foundation Type

FOUNDATION RELEVELING OBSERVED

Concrete releveling is observed to the floor slab. The repair appears to have been made to a trades like manner

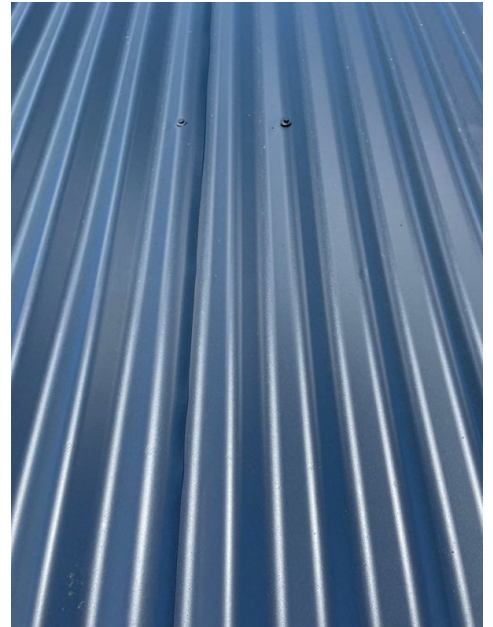
This roof has been recently painted, which can make the detection of defects difficult.

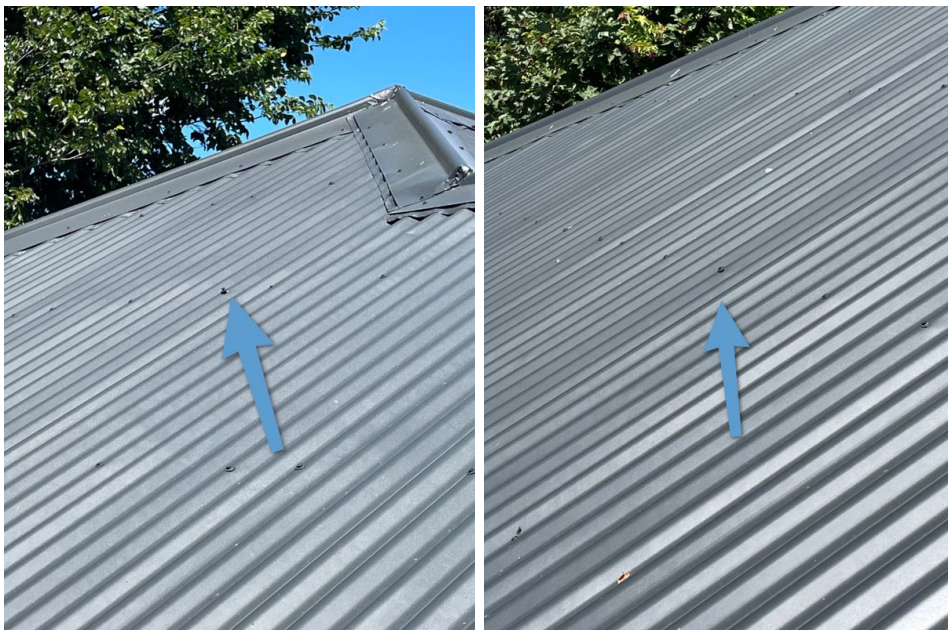
19.1.2 Roofing Material

LOOSE OR DAMAGED FIXINGS

There are some loose or damaged fixings that should be pulled and replaced.

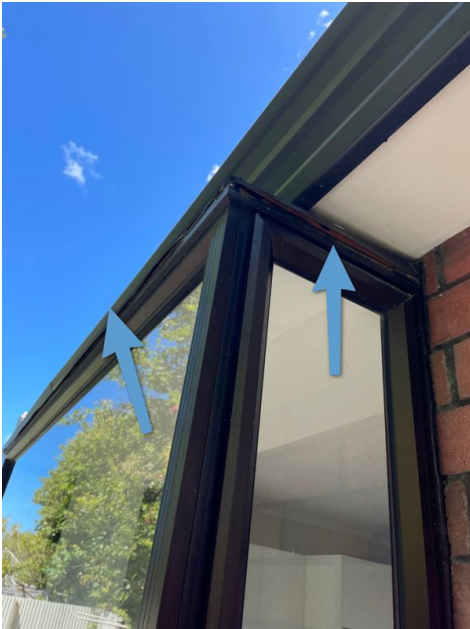
19.2.1 Side roof

LIFTING MEMBRANE

The rubber membrane is lifting at the perimeter across the highlighted areas of roof. Repair or replacement by a licensed roofer is required

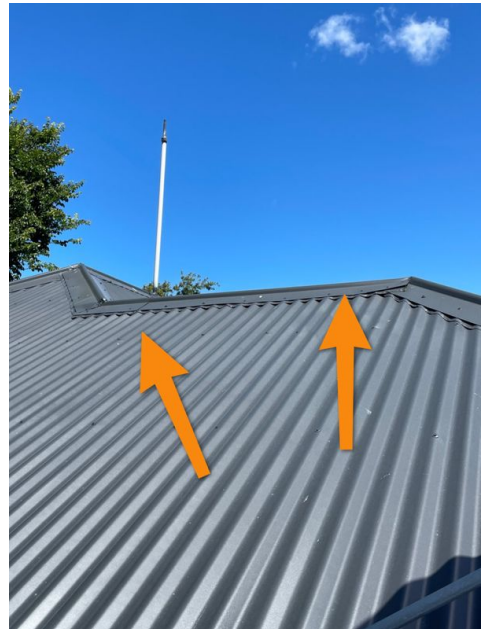
19.3.1 Flashings & Parapets

LIFTING SOFT EDGE

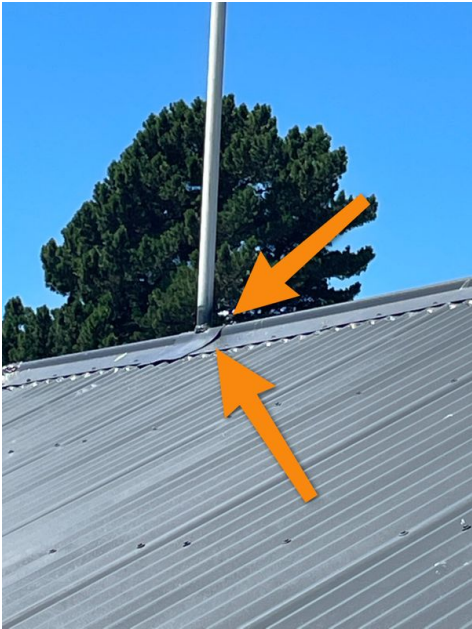
19.4.1 Vents

SEAL AROUND FLASHING

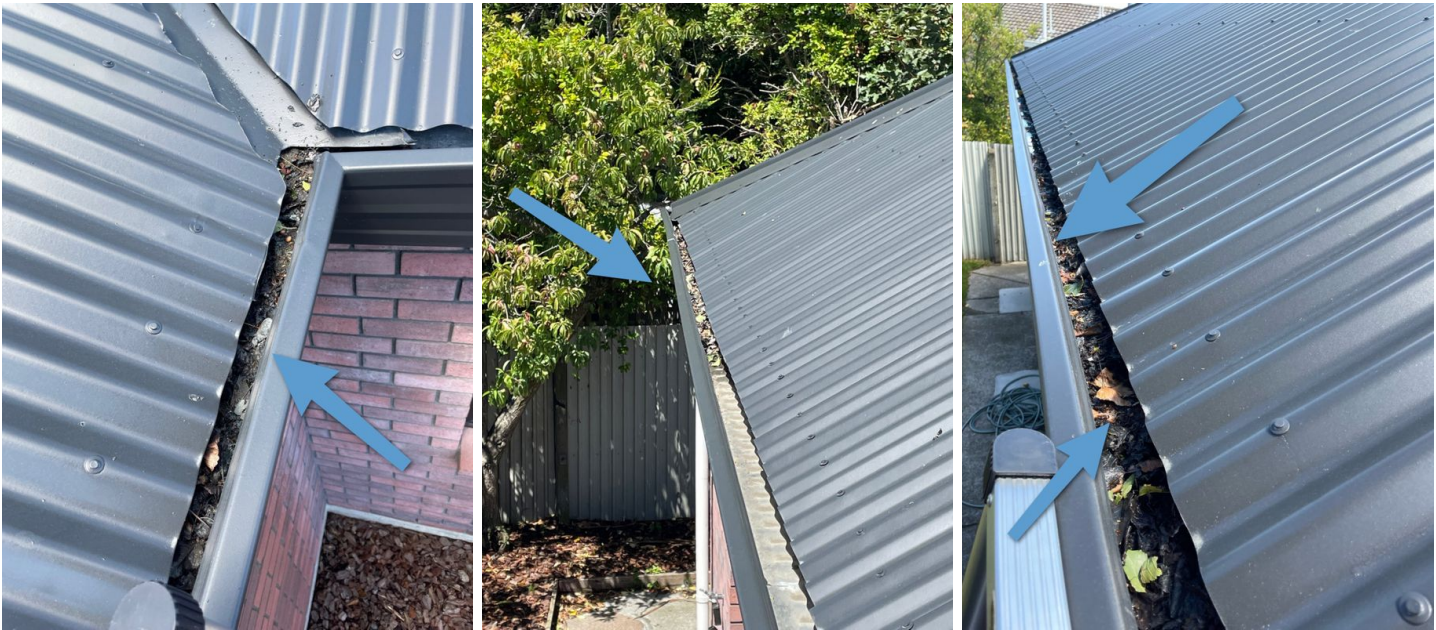
19.5.1 Gutters & Spouting
BLOCKED SPOUTING

The spouting is full of debris and requires clearing to allow water to drain freely.

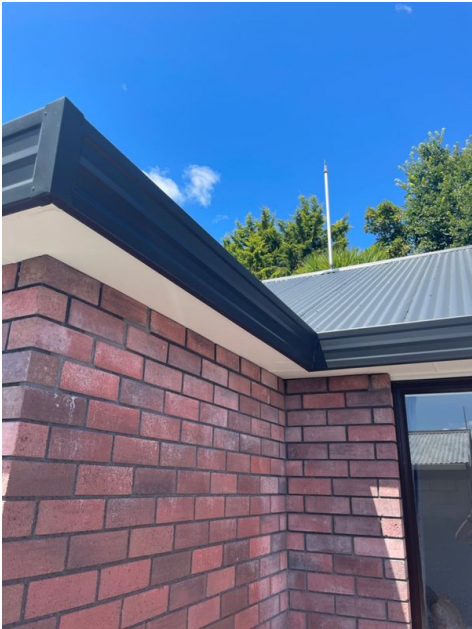
This home has a concealed spouting system, if the spouting blocks or the joints start to leak, water can penetrate into the soffit and discharge back into the house. This is a weather tightness risk area.
