# INSIGHT BUILDING INSPECTIONS

## RESIDENTIAL INSPECTION

94A Chelsea St  
Christchurch, Canterbury 8062

JANUARY 27, 2025

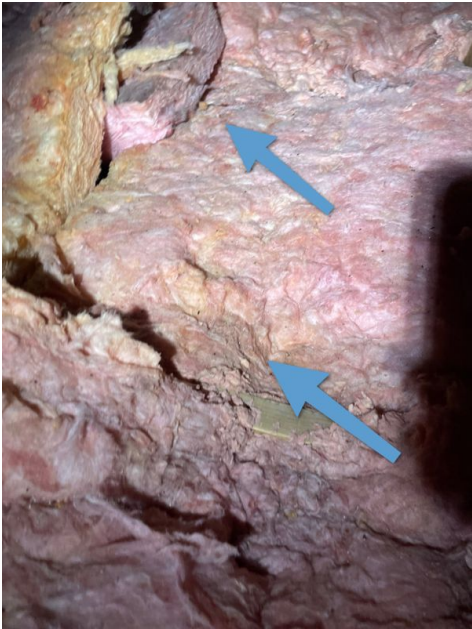
## 13.5.1 Pest &amp; Insect

**RODENT SIGN**

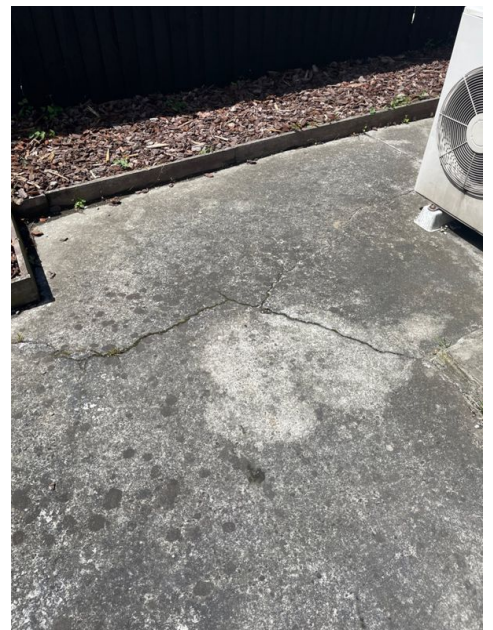
### 16.3.1 Path & Patios

#### CRACKING TO CONCRETE PATHS

There are hairline cracks to the concrete paths, this is common and is generally caused by shrinkage / movement of the material. These areas can be repaired or replaced by a concrete placer if desired

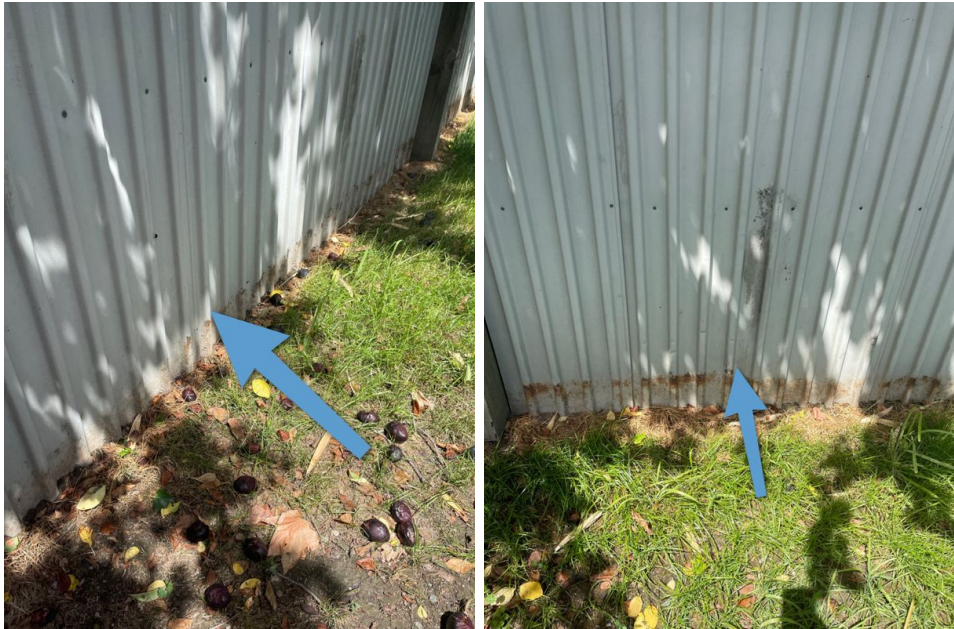
### 16.5.2 Fencing

#### **CORROSION TO METAL FENCE**

There is corrosion to the metal fence. Treatment and recoating of these areas is advised

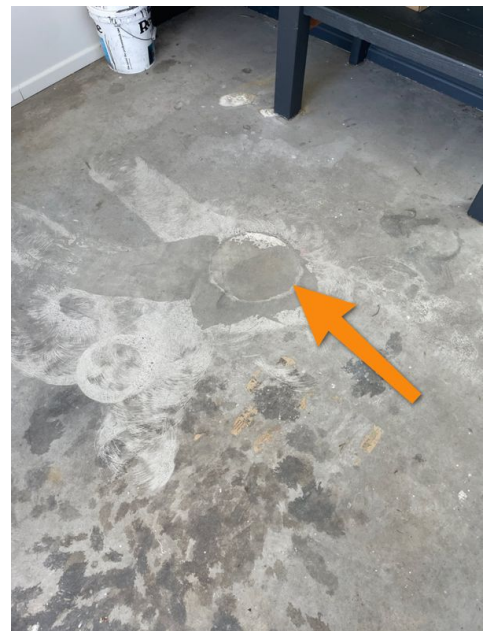
### FOUDNATION RELEVELING OBSERVED

Concrete releveling is observed to the floor slab. The repair appears to have been made to a trades like manner

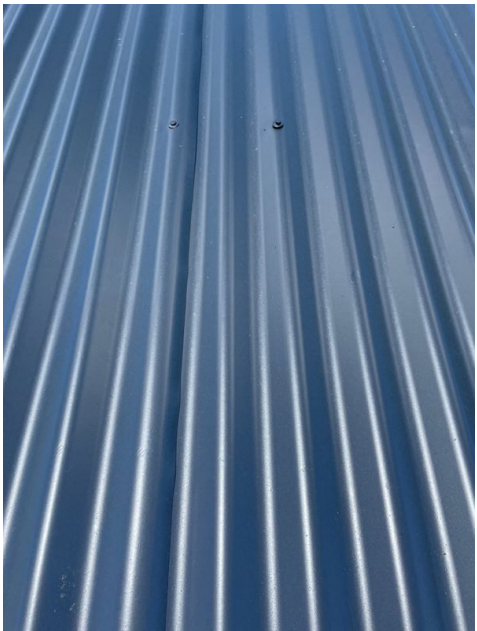
This roof has been recently painted, which can make the detection of defects difficult.

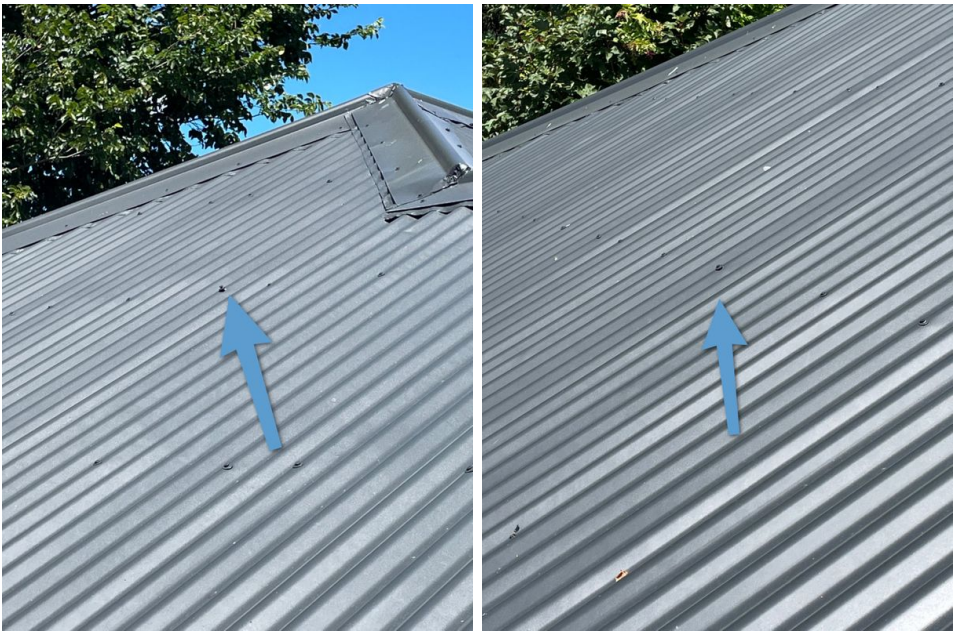
19.1.2 Roofing Material

**LOOSE OR DAMAGED FIXINGS**

There are some loose or damaged fixings that should be pulled and replaced.

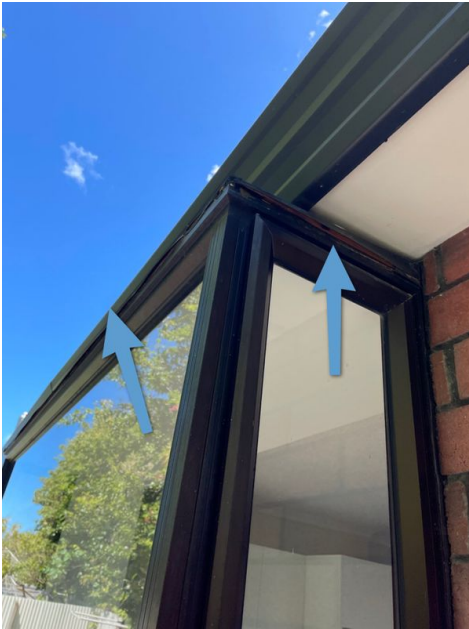
19.2.1 Side roof

**LIFTING MEMBRANE**

The rubber membrane is lifting at the perimeter across the highlighted areas of roof. Repair or replacement by a licensed roofer is required

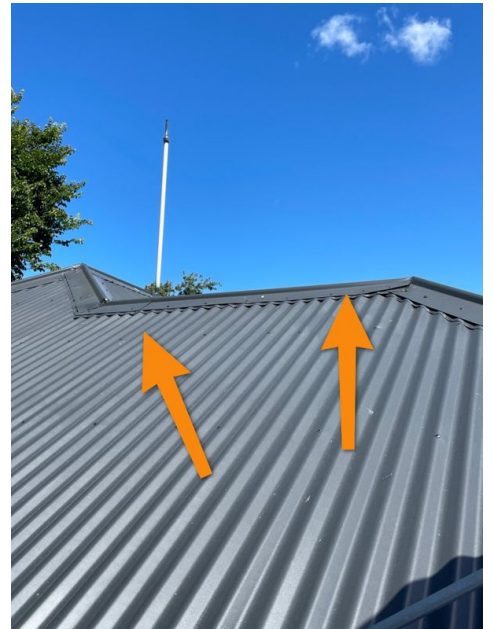
### 19.3.1 Flashings & Parapets

#### **LIFTING SOFT EDGE**

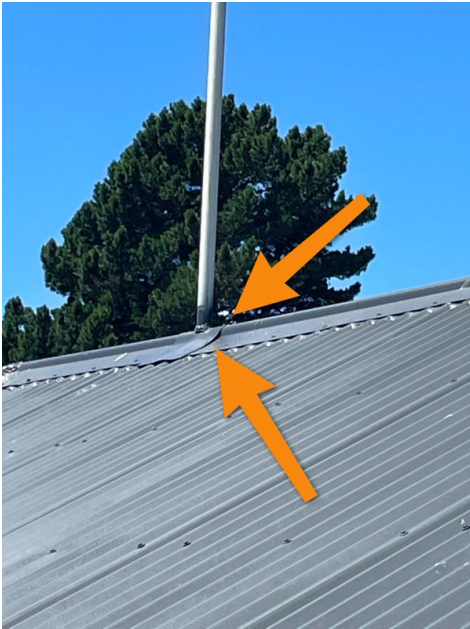
### 19.4.1 Vents

#### **SEAL AROUND FLASHING**

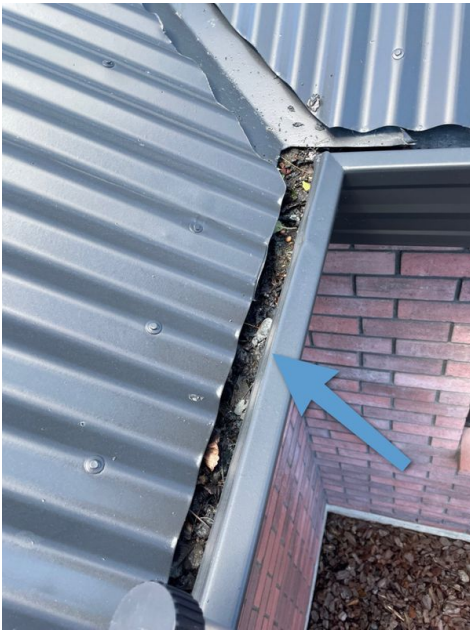
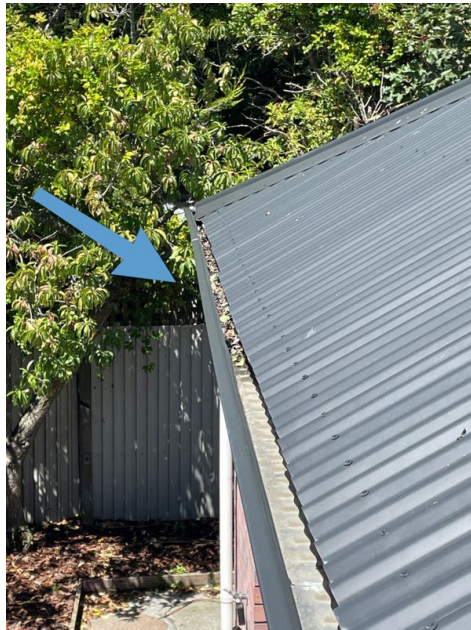
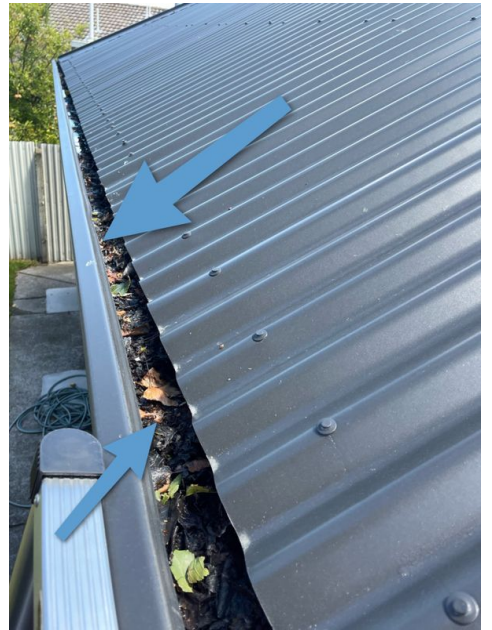
## 19.5.1 Gutters &amp; Spouting

**BLOCKED SPOUTING**

The spouting is full of debris and requires clearing to allow water to drain freely.
