94A Chelsea St

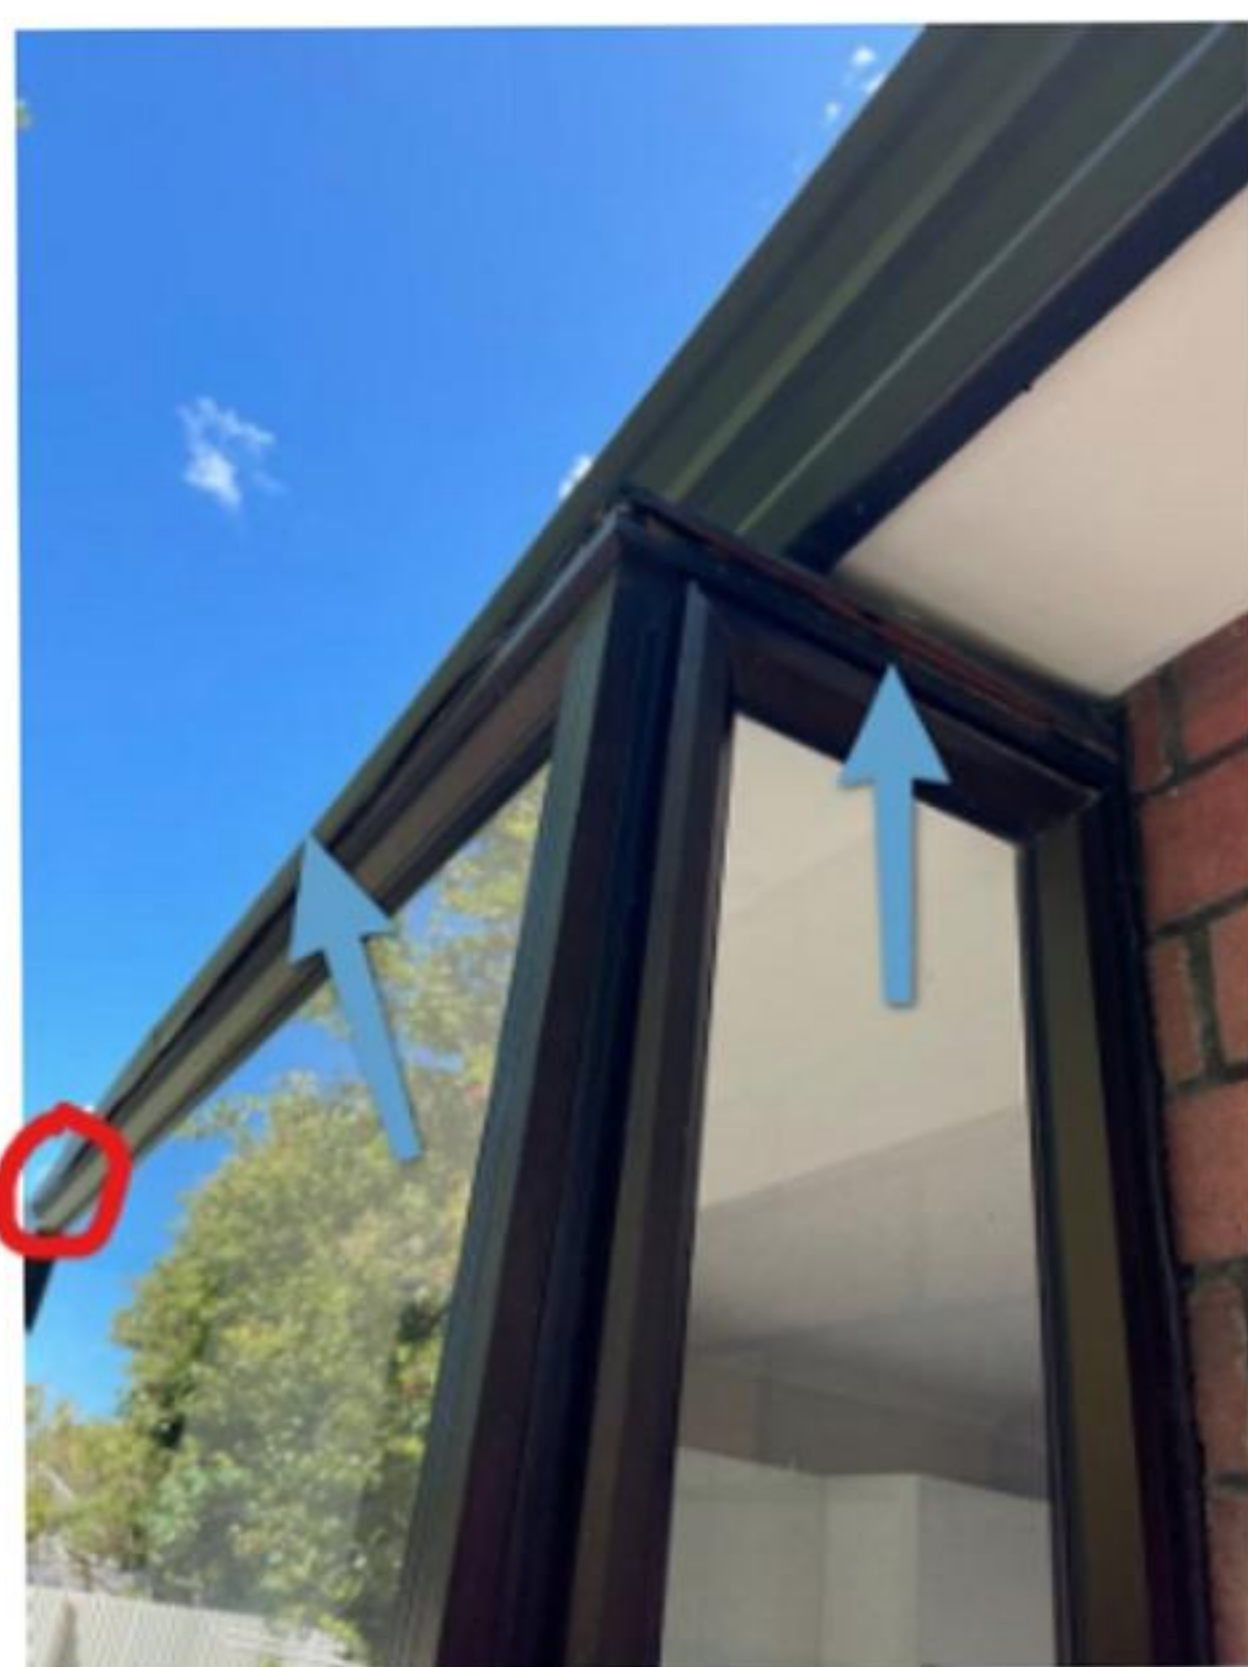
This was glued back down at the time as the building report requested and you can see the orange glue there also.

More so the water ingress is now showing on the left hand end where I have circled in red, This was not a problem at time of report, So in turn this would just be ongoing monitoring and maintenance

See below I have circled in red where the moisture is showing internally
