RESIDENTIAL INSPECTION

94A Chelsea St
Christchurch, Canterbury 8062

JANUARY 27, 2025

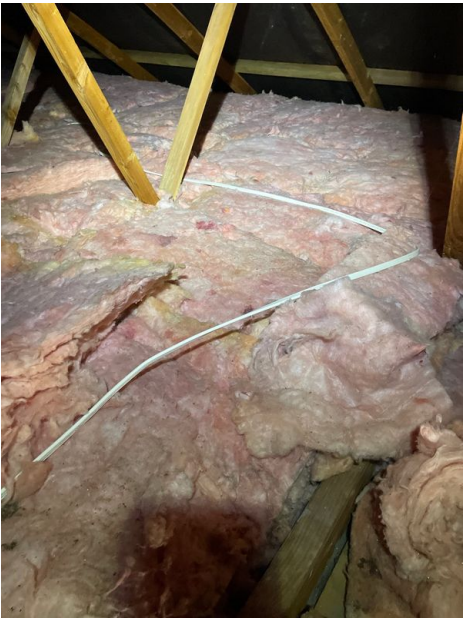
Visible Electrical Wiring: Type
TPS cable

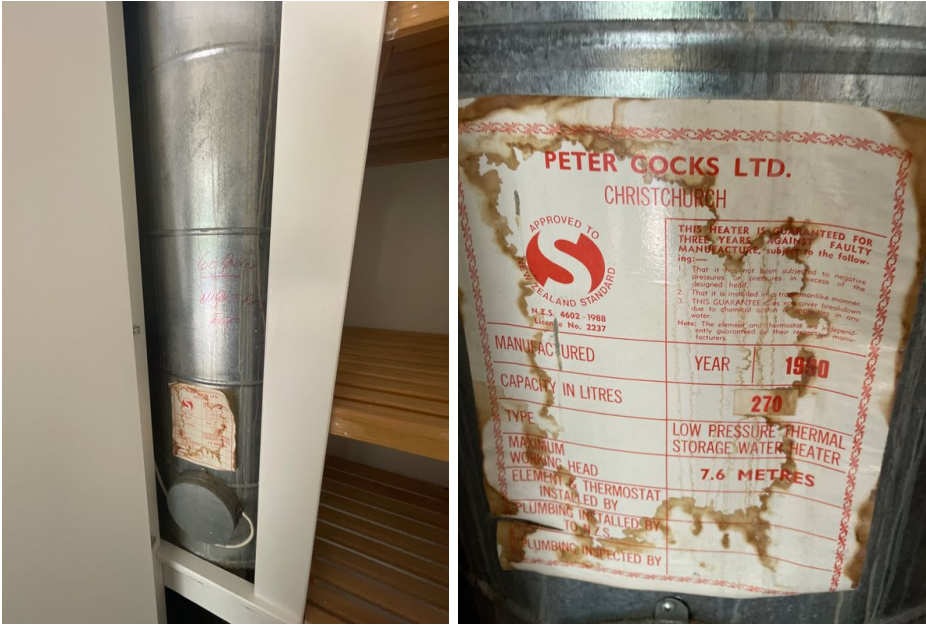
Photo

The HWC is beyond its life expectancy and should be considered for replacement

We recommend fitting seismic restraints to prevent movement during an earthquake.

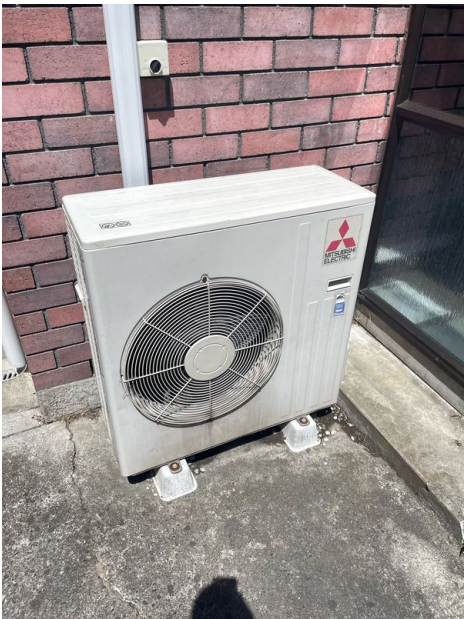
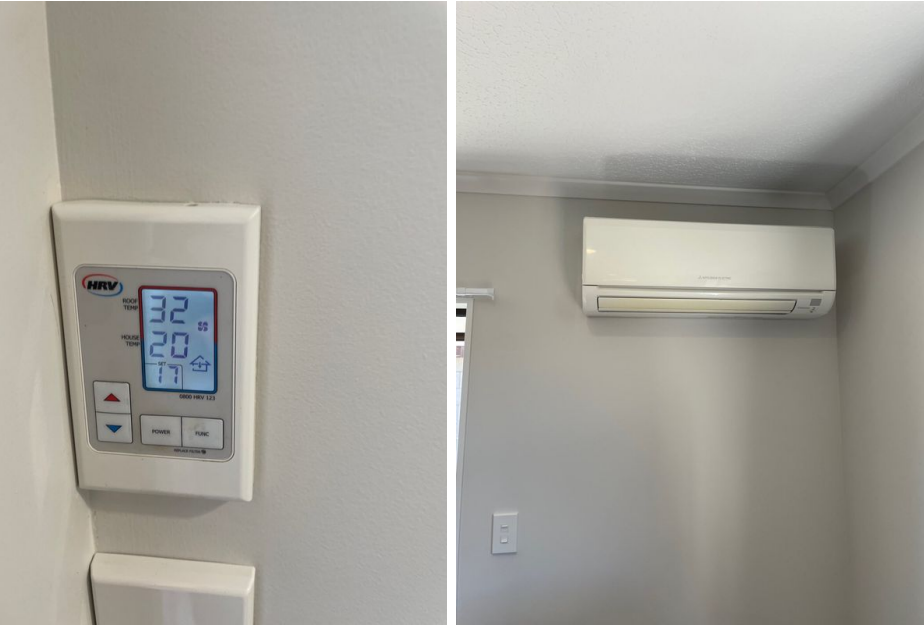
Heating & Air Conditioning: Photo

The heatpump was not powering up at the time of inspection. All switches appeared to be on. It is recommended that the unit be tested at settlement inspection and repaired if required

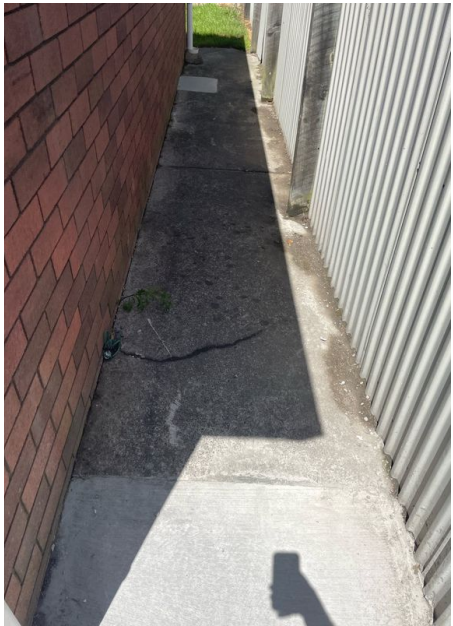
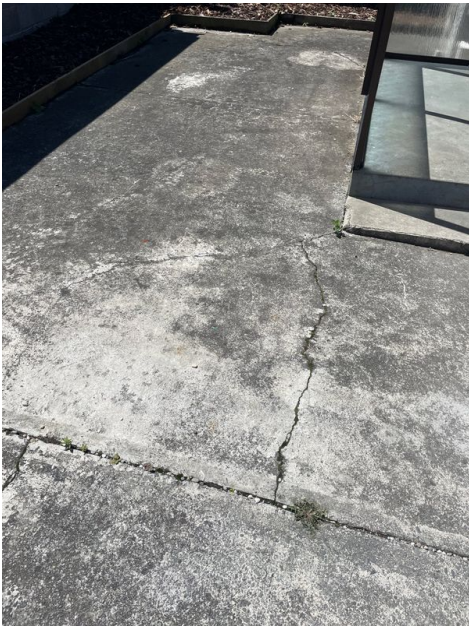
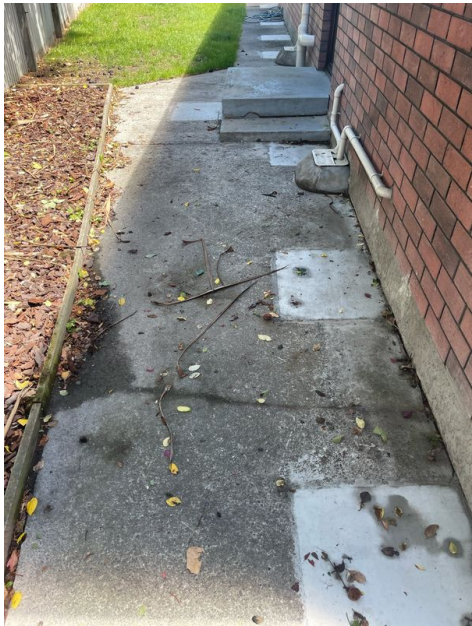
Path & Patios: Material
Concrete

CRACKING TO CONCRETE PATHS

There are hairline cracks to the concrete paths, this is common and is generally caused by shrinkage / movement of the material. These areas can be repaired or replaced by a concrete placer if desired

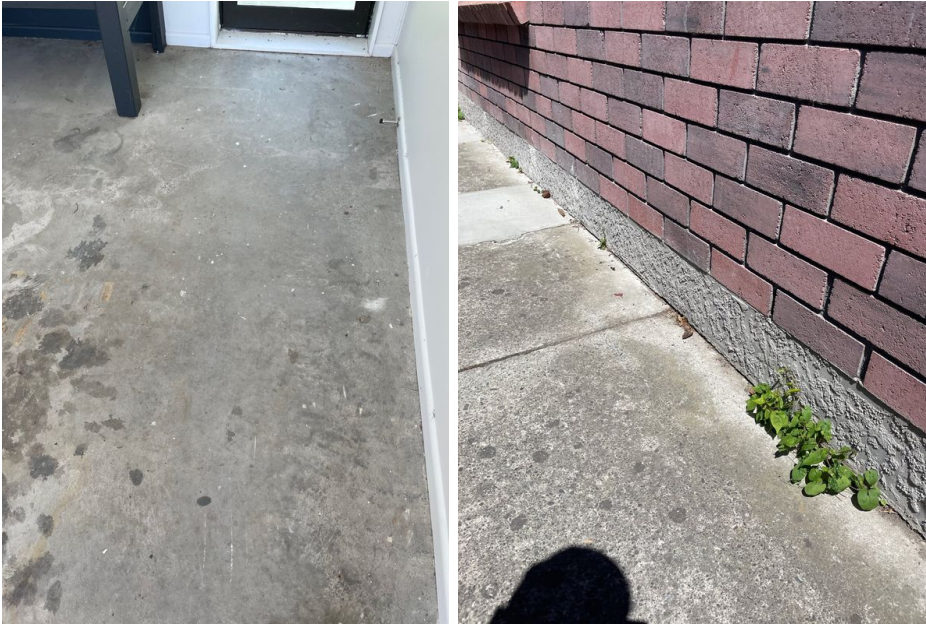
Spot floor levels were taken. An approximate variation of 16mm was recorded. This measurement is within MBIE guidelines which state a maximum allowable variation of 50mm across the floor plate.
