# INSIGHT BUILDING INSPECTIONS

## RESIDENTIAL INSPECTION

94A Chelsea St  
Christchurch, Canterbury 8062

JANUARY 27, 2025

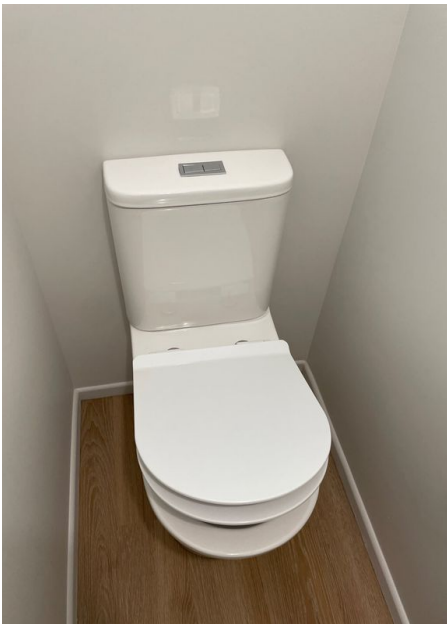
Toilet appears correctly and certainly fixed.

Half flush and full flush appear to be in **good** working order.

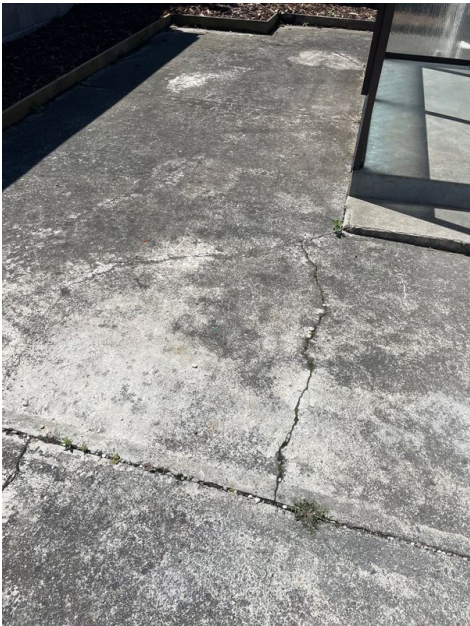
**Path & Patios: Material**  
Concrete

There are hairline cracks to the concrete paths, this is common and is generally caused by shrinkage / movement of the material. These areas can be repaired or replaced by a concrete placer if desired

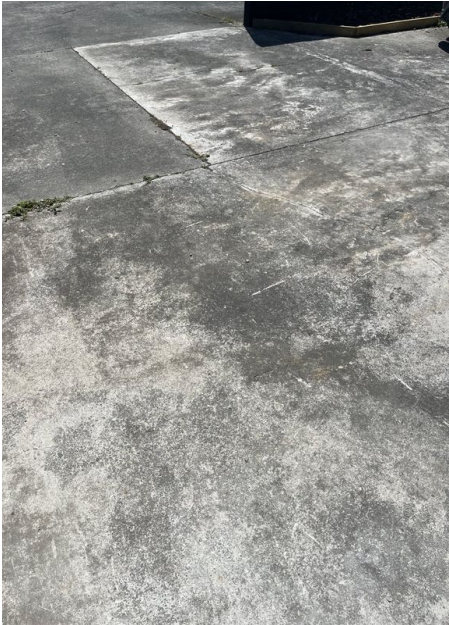
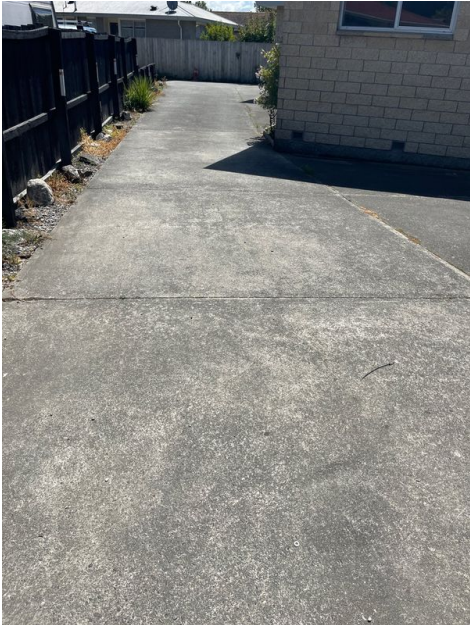
**Driveway: Material**  
Concrete

There are hairline cracks to the concrete paths, this is common and is generally caused by shrinkage / movement of the material. These areas can be repaired or replaced by a concrete placer if desired

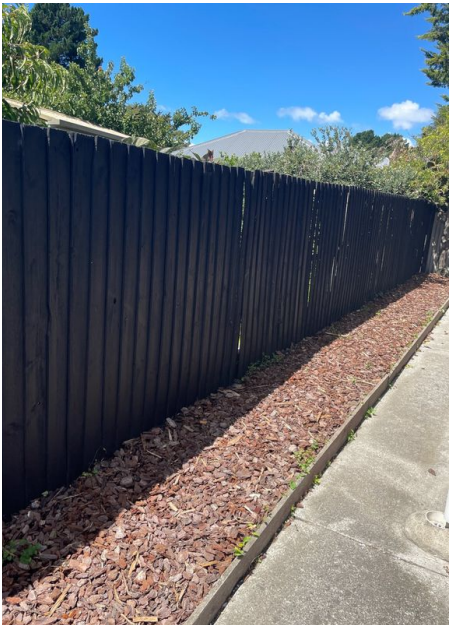
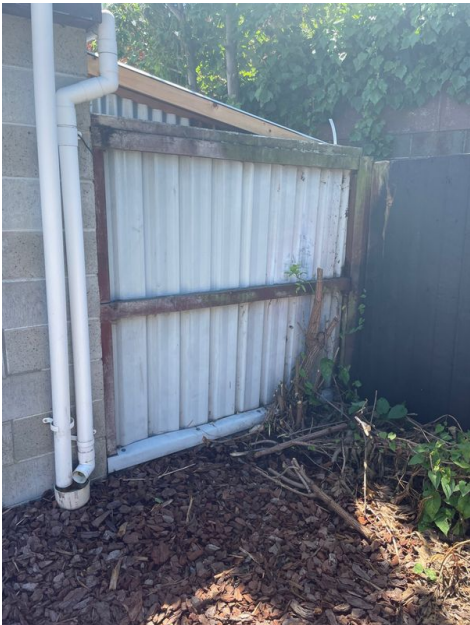
**Fencing: Material**  
Timber, Metal

The timber fencing is hard to the ground in areas. This will cause the fence palings to rot in time. It is recommended that clearances are instated to these areas

There is corrosion to the metal fence. Treatment and recoating of these areas is advised

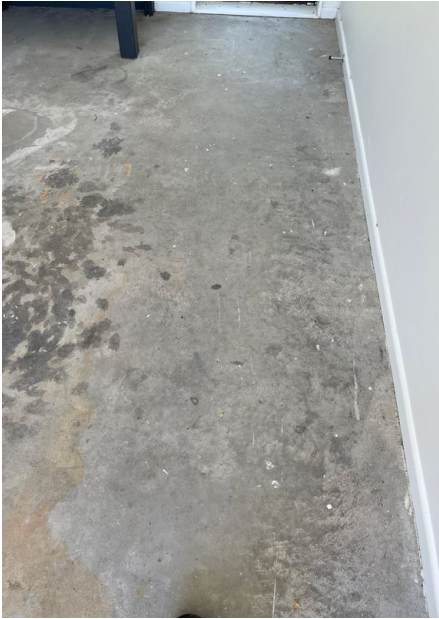
Concrete releveling is observed to the floor slab. The repair appears to have been made to a trades like manner

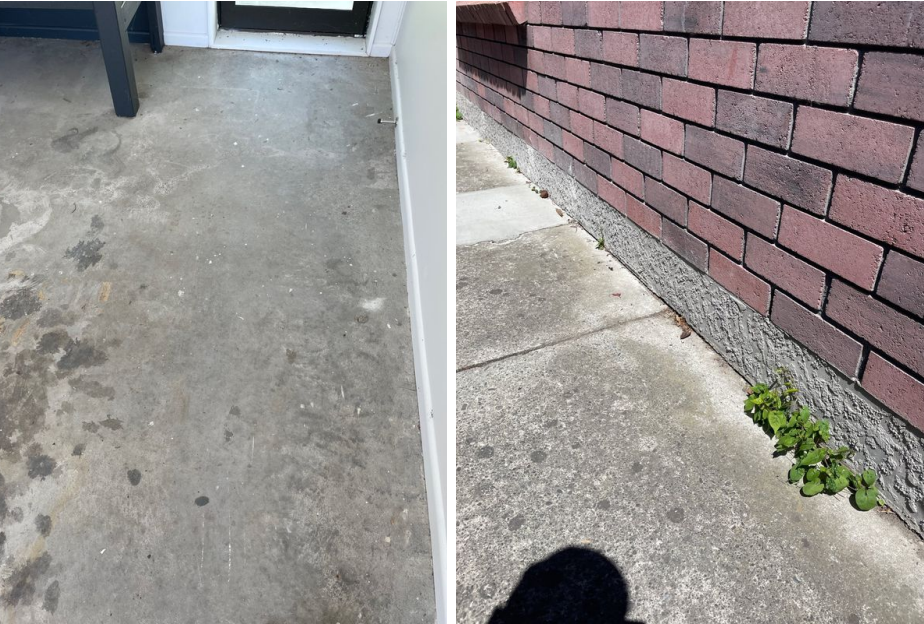
Photo

Spot floor levels

Spot floor levels were taken. An approximate variation of 16mm was recorded. This measurement is within MBIE guidelines which state a maximum allowable variation of 50mm across the floor plate.

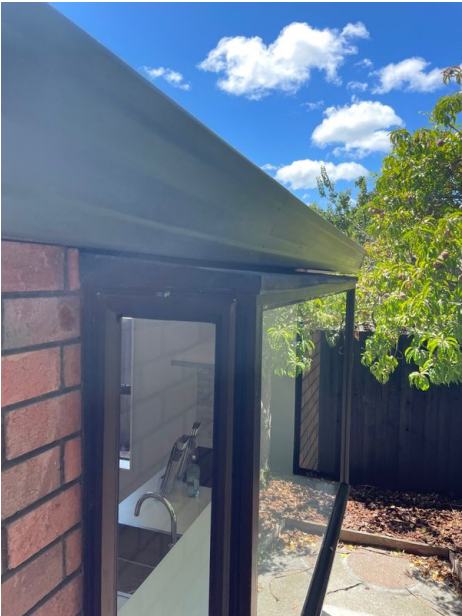
Side roof: Material  
Rubber Membrane

The rubber membrane is lifting at the perimeter across the highlighted areas of roof. Repair or replacement by a licensed roofer is required

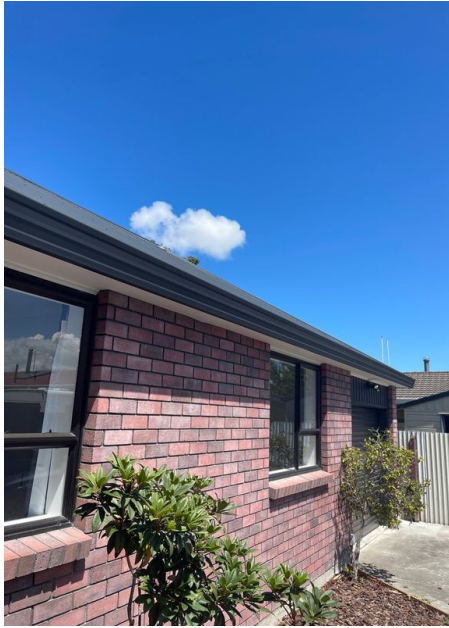
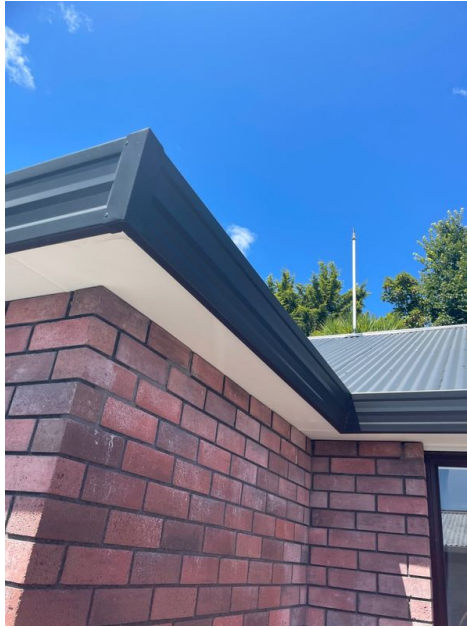
## Fascias & Barge Boards: Material

This home has a concealed spouting system, if the spouting blocks or the joints start to leak, water can penetrate into the soffit and discharge back into the house. This is a weather tightness risk area.

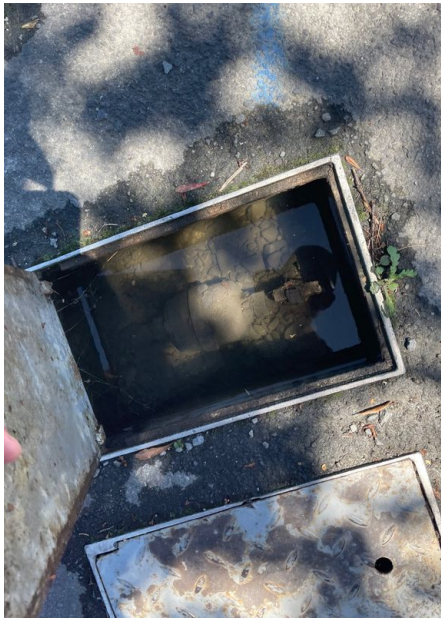
#### Water Shut Off: Location

Water toby
